**1977-1978 WINTER TEST  
SITE REPORT  
FOR  
PERIPHERAL PARKING AREAS**

XIII OLYMPIC WINTER  
GAMES · LAKE PLACID · 1980

**PREPARED  
FOR  
OLYMPIC  
TRANSPORTATION  
COMMITTEE**

**SOIL MECHANICS BUREAU  
NEW YORK STATE  
DEPARTMENT OF TRANSPORTATION**

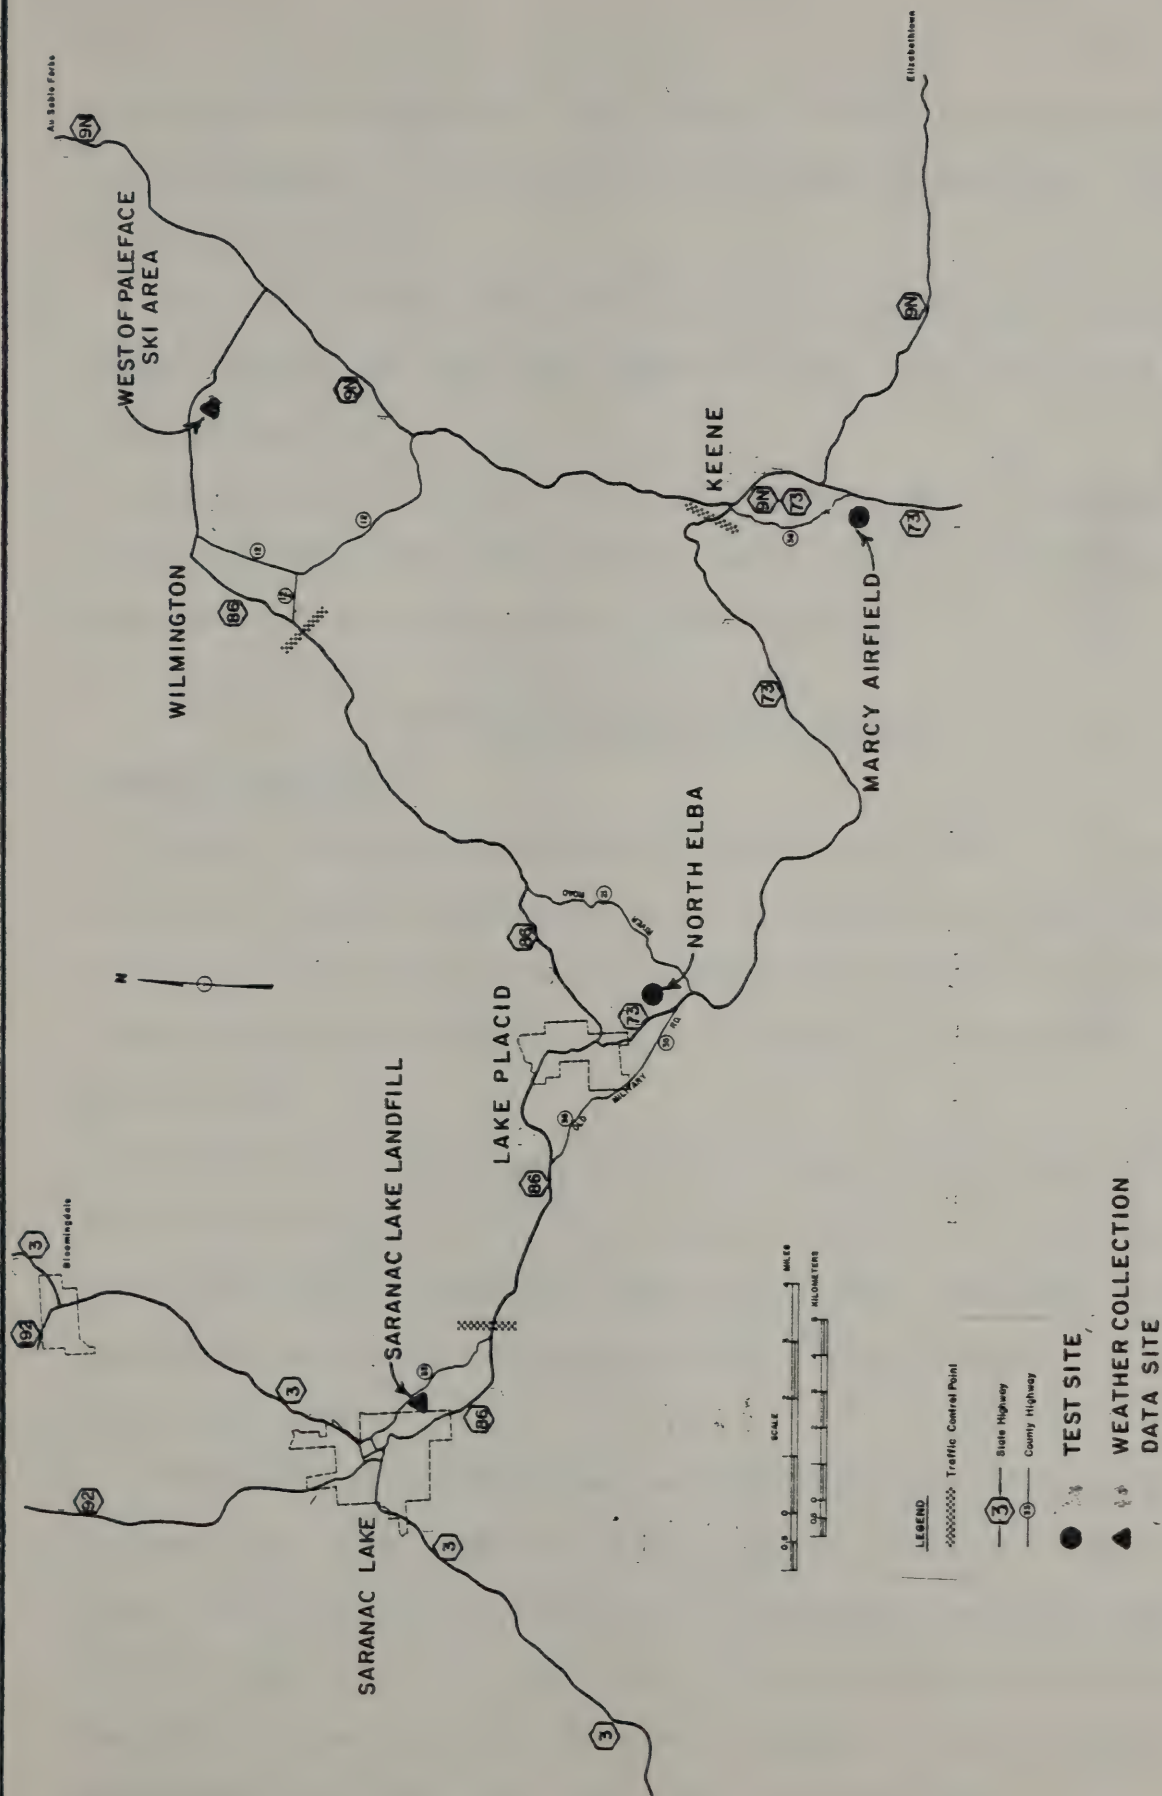
FIGURE 1

XIII WINTER OLYMPIC GAMES  
 PERIPHERAL PARKING TEST SITE PROGRAM  
 1977-78  
 TEST AND WEATHER COLLECTION DATA SITES

During the winter of 1977-78 two test sites were constructed to determine the types of parking surfaces that would satisfy the project objectives. These surfaces were observed under test traffic through the range of climatic conditions that could potentially occur during the 1980 Winter Olympics. Serviceability was determined by periodically driving and parking trucks and automobiles on the various areas, then observing and recording performance for both traction and support behavior. Climatic data including daily maximum and minimum temperature, and weekly snow and frost depth measurements were made at the test sites and also at two other locations on travel corridors to Lake Placid. Figure 1 shows the location of the project activities.

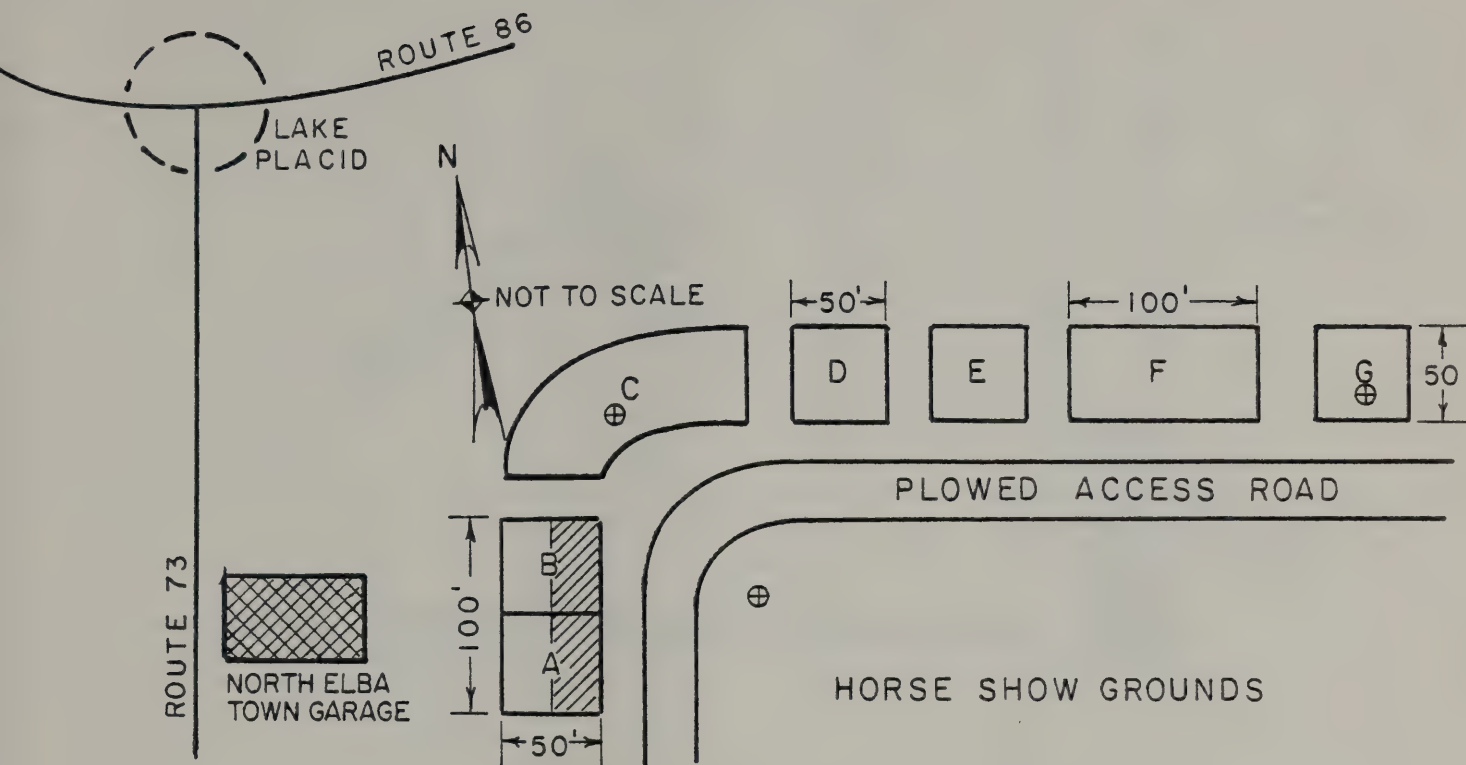
FIGURE 2

NORTH ELBA TEST SITE  
TEST DETAILS - 1977-78

- ⊕ Frost Gauge
- [A] Twelve inches compacted gravel on bare ground and on Filter Fabric

- [B] Six inches compacted gravel on bare ground and on Filter Fabric

- [C] Bare ground - kept plowed all winter
- [D] Bare ground - sawdust cover
- [E] Compacted snow - sawdust - snow surface
- [F] Compacted snow
- [G] Bare ground - plowed after February 1

of the gravel were placed on filter fabric to evaluate its benefits in the cleanup operation. A location plan of the basic treatments and variations is shown on Figure 2.

The sections were constructed in sequence as shown on Figure 2. The gravel sections, 6 inches and 12 inches thick, were placed in November. A filter fabric, 25 feet wide and 100 feet long, was placed on the ground surface under half of the sections. The plastic filter fabric was Mirafi 140 manufactured by the Celanese Corporation of America. The purpose of the fabric was to determine if it improved the trafficability of the gravel and if it would benefit the cleanup operation. The two bare ground test sections and the gravel sections were plowed by the North Elba Town Highway Department. One bare ground section was plowed all winter and the second section after February 1. Photographs 1 and 2 show portions of the test site.

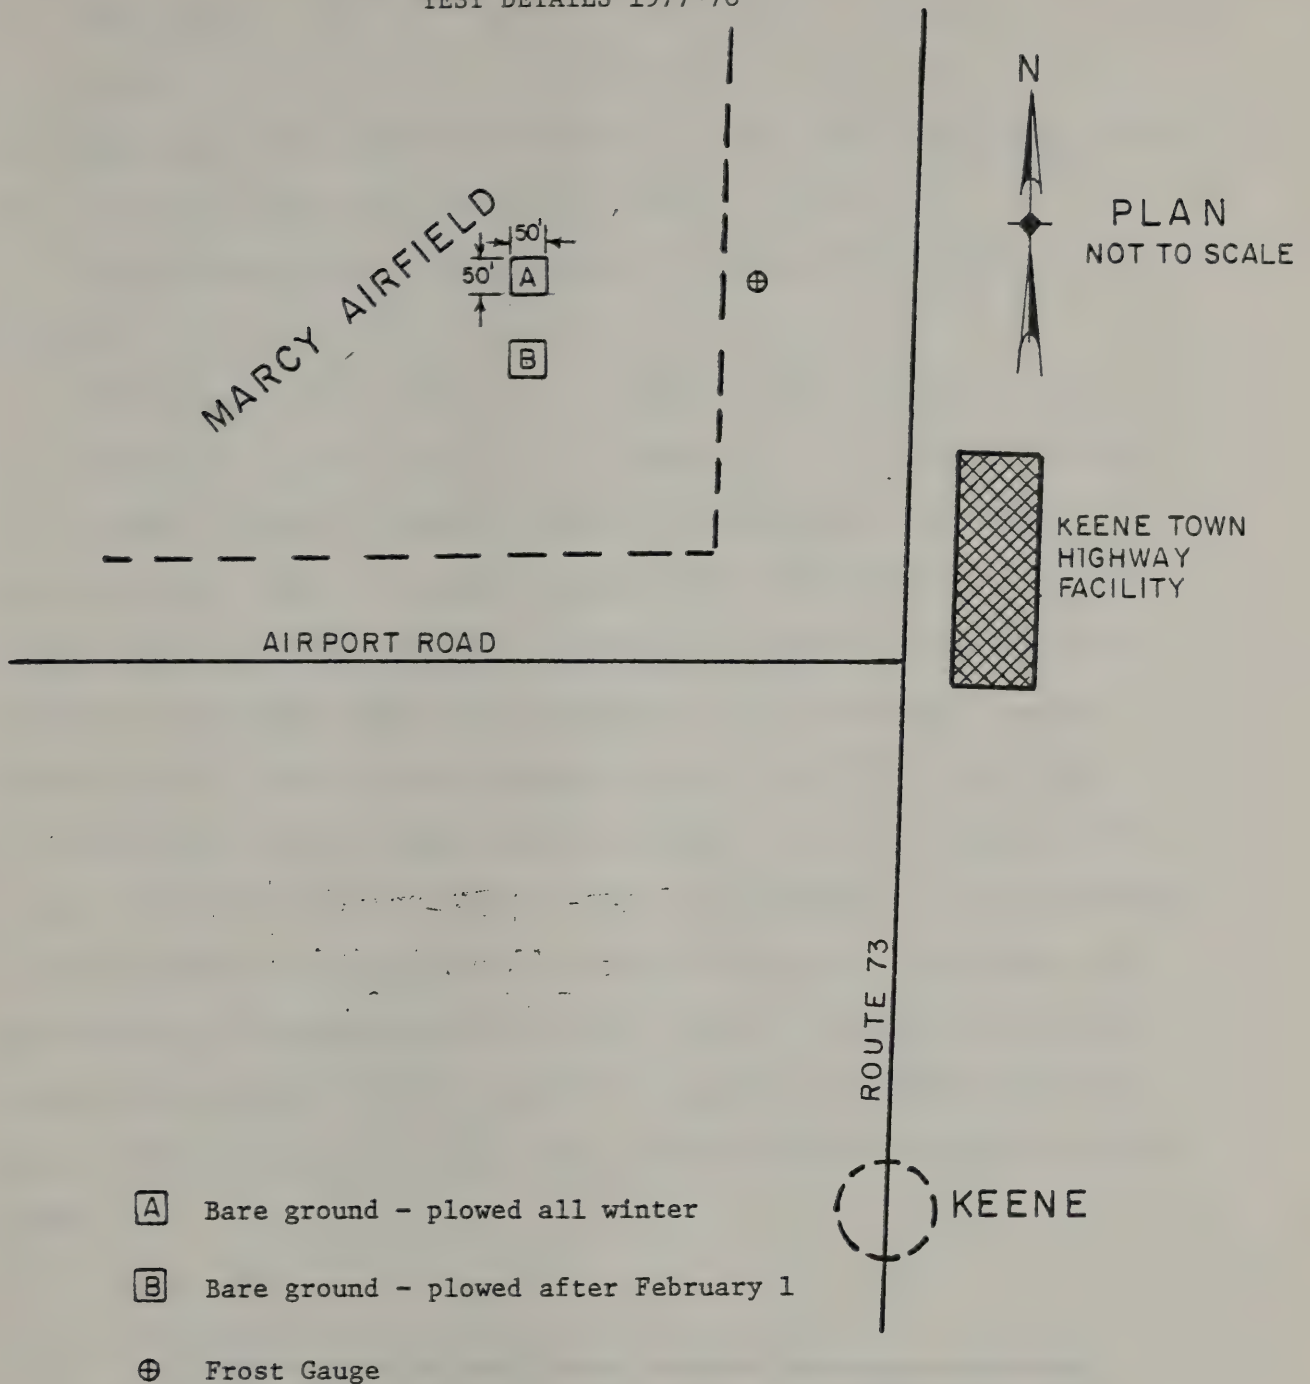
FIGURE 3

MARCY AIRFIELD TEST SITE  
LOCATION - EAST END OF AIRPORT  
OPPOSITE KEENE TOWN HWY. FACILITY  
TEST DETAILS 1977-78

A smaller secondary test site was located at the east end of Marcy Airport opposite the Keene Town Highway Facility. The test details are shown on Figure 3.

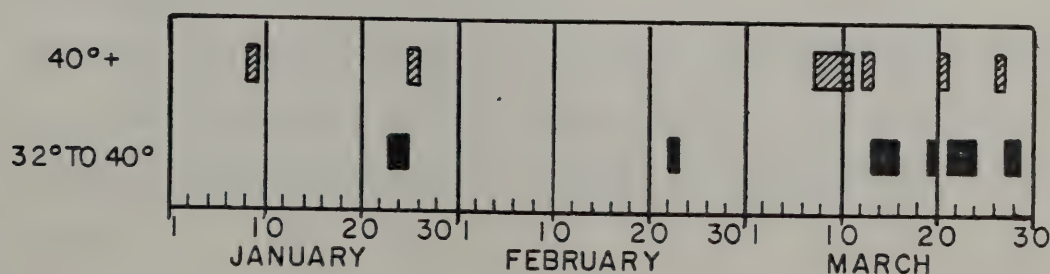
Figure 4 - Maximum Temperatures Above 32°F at North Elba Test Site

The most critical climatic conditions affecting the performance of the parking surface will be during a thaw period. These climatic conditions can be measured by the magnitude of temperature above freezing and the number of consecutive days with temperatures above freezing. During February 1978, above freezing temperatures were recorded on one day. This was unusual since temperature records for the last 15 years at Marble Lodge, Whiteface Mountain indicate there is an average of 3 days in February when the maximum daily temperature is above 40°F and 6.5 days when the maximum daily temperature is between 32° and 40°F. A graphical maximum temperature summary chart is included in Appendix B. Figure 4 shows the days on which temperatures were above 32°F at the North Elba Test Site in 1978.

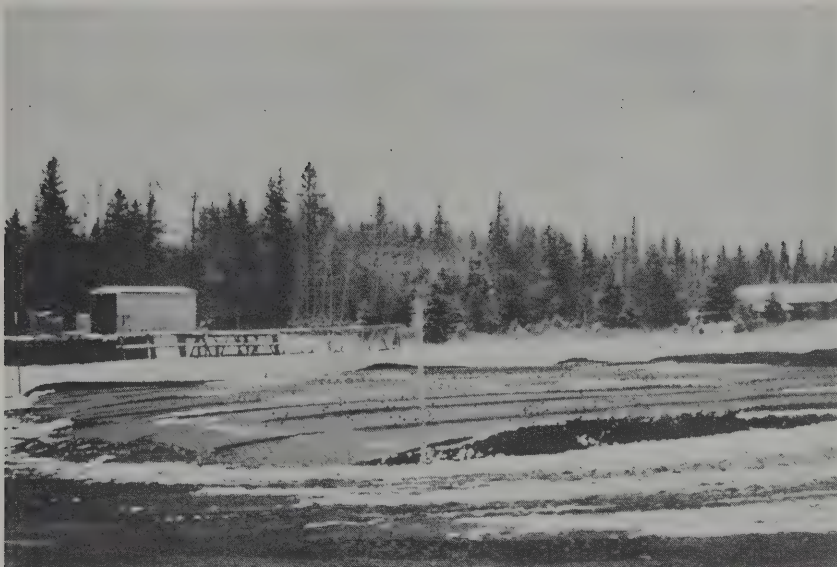
PHOTOGRAPH 1 - Gravel Pad Test Sections

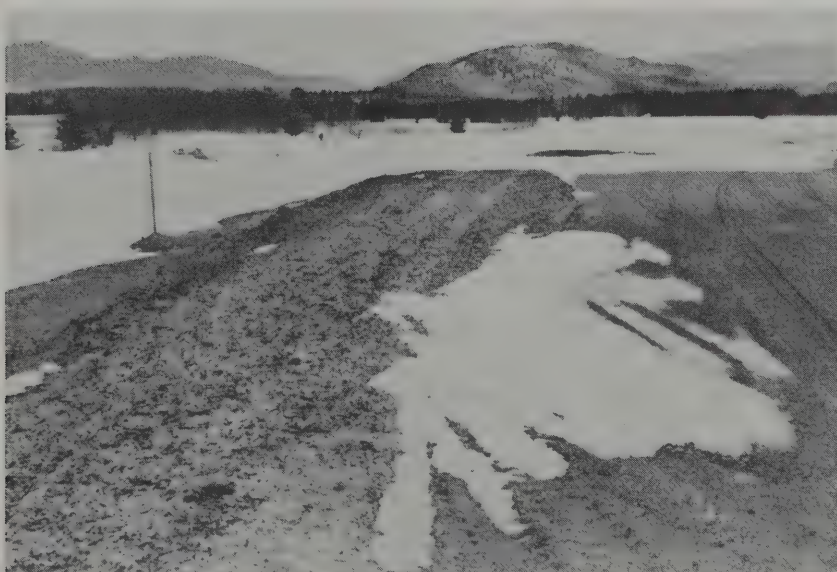
PHOTOGRAPH 2 - Sawdust Cover Test Section

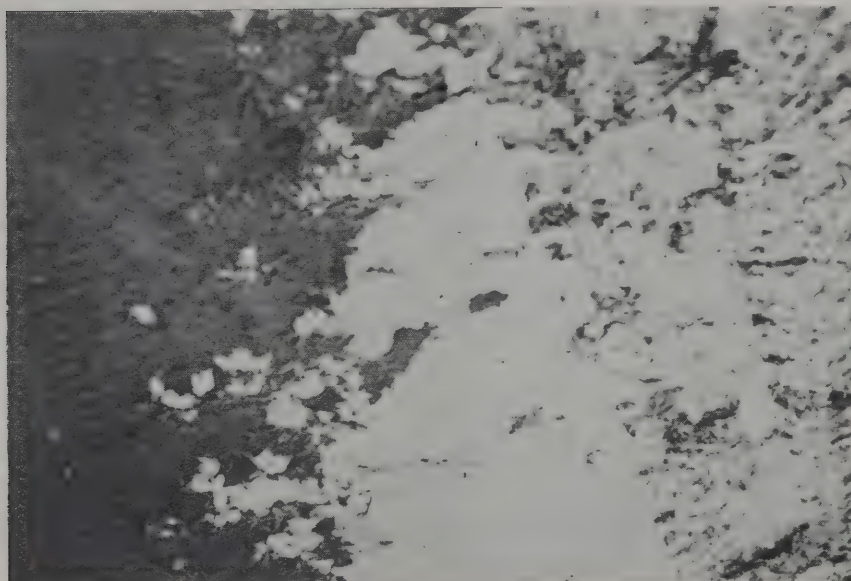
PHOTOGRAPH NO. 3 - Tire imprints on  
bare ground (left) and gravel  
pad (right) at N. Elba Test Site

Atmospheric Science Research Center, Whiteface Mountain Field Station at Marble Lodge is also shown. The performance testing indicated no rutting at North Elba after 7 days of thawing weather and 1/2 inch ruts at Keene after four days of thaw. Photograph No. 3 shows tire imprints on bare-ground and on the gravel pad at North Elba during this time period.

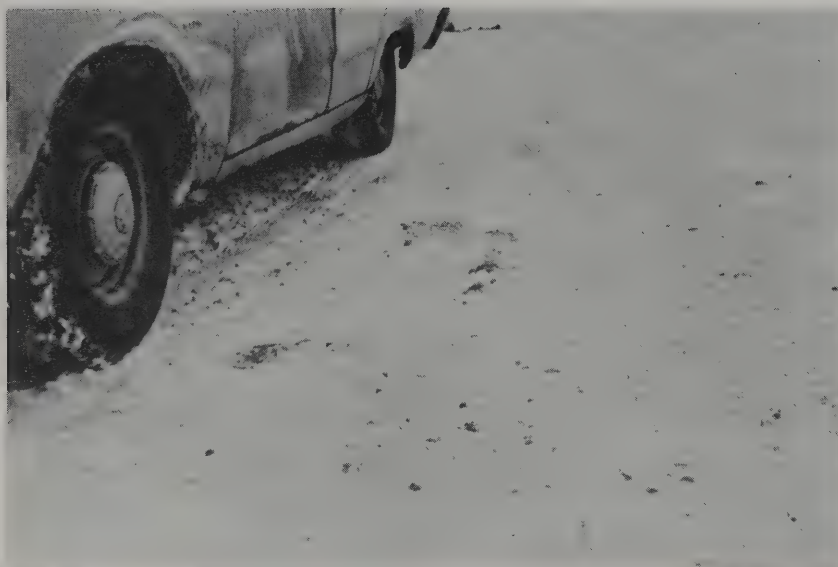
PHOTOGRAPH NO. 4 - Condition of Parking Surface  
at Horseshow ground - World Games Parking

A large scale test was provided by parking for the World Games held February 8-13, 1978. The Horseshow track was plowed a week before to accommodate parking on February 12 and 13. The lot was used by 600 to 800 cars on the two days and busses traveled through the area. The daytime temperature was below freezing during this period. No rutting or traction problems were experienced in the parking area. One to two inches of snow fell on each day and it did not affect traction. The soil was the same as the test section except there was no grass cover. Rutting did occur in a localized area on the access road where there was a depression filled with snow.

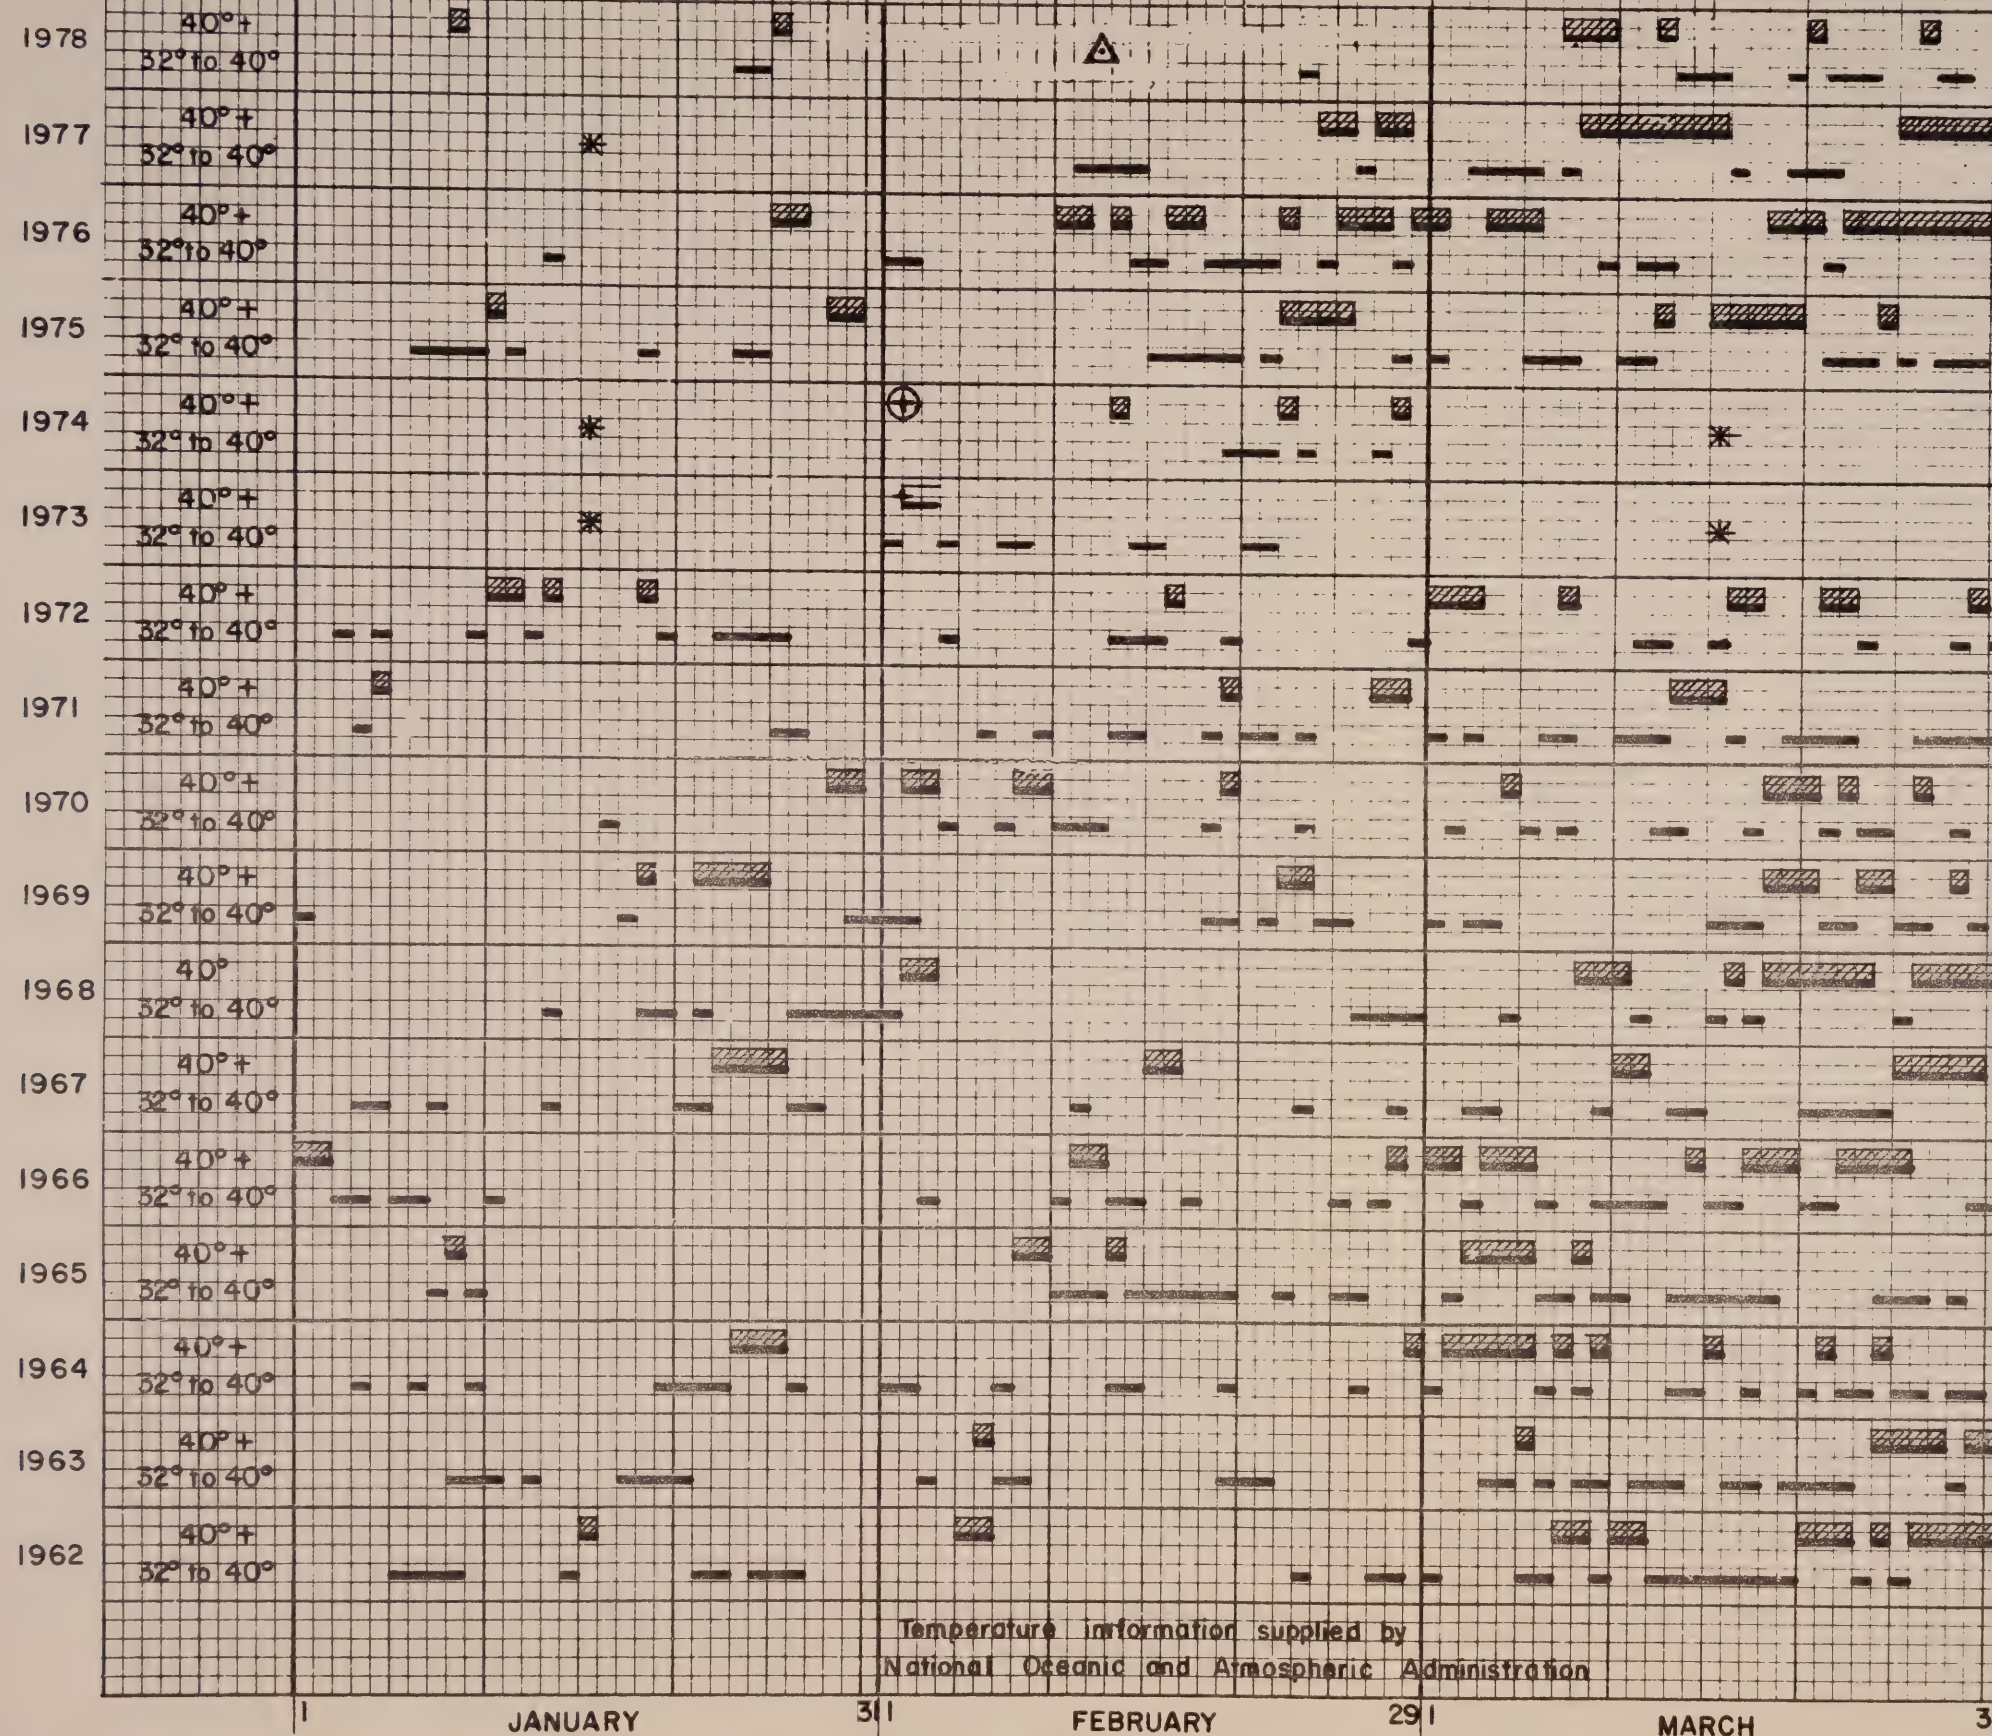
FIGURE B-1

Maximum Temperature above 32°F  
Versus Days

Data From Lake Placid Club

Temperature information supplied by  
National Oceanic and Atmospheric Administration

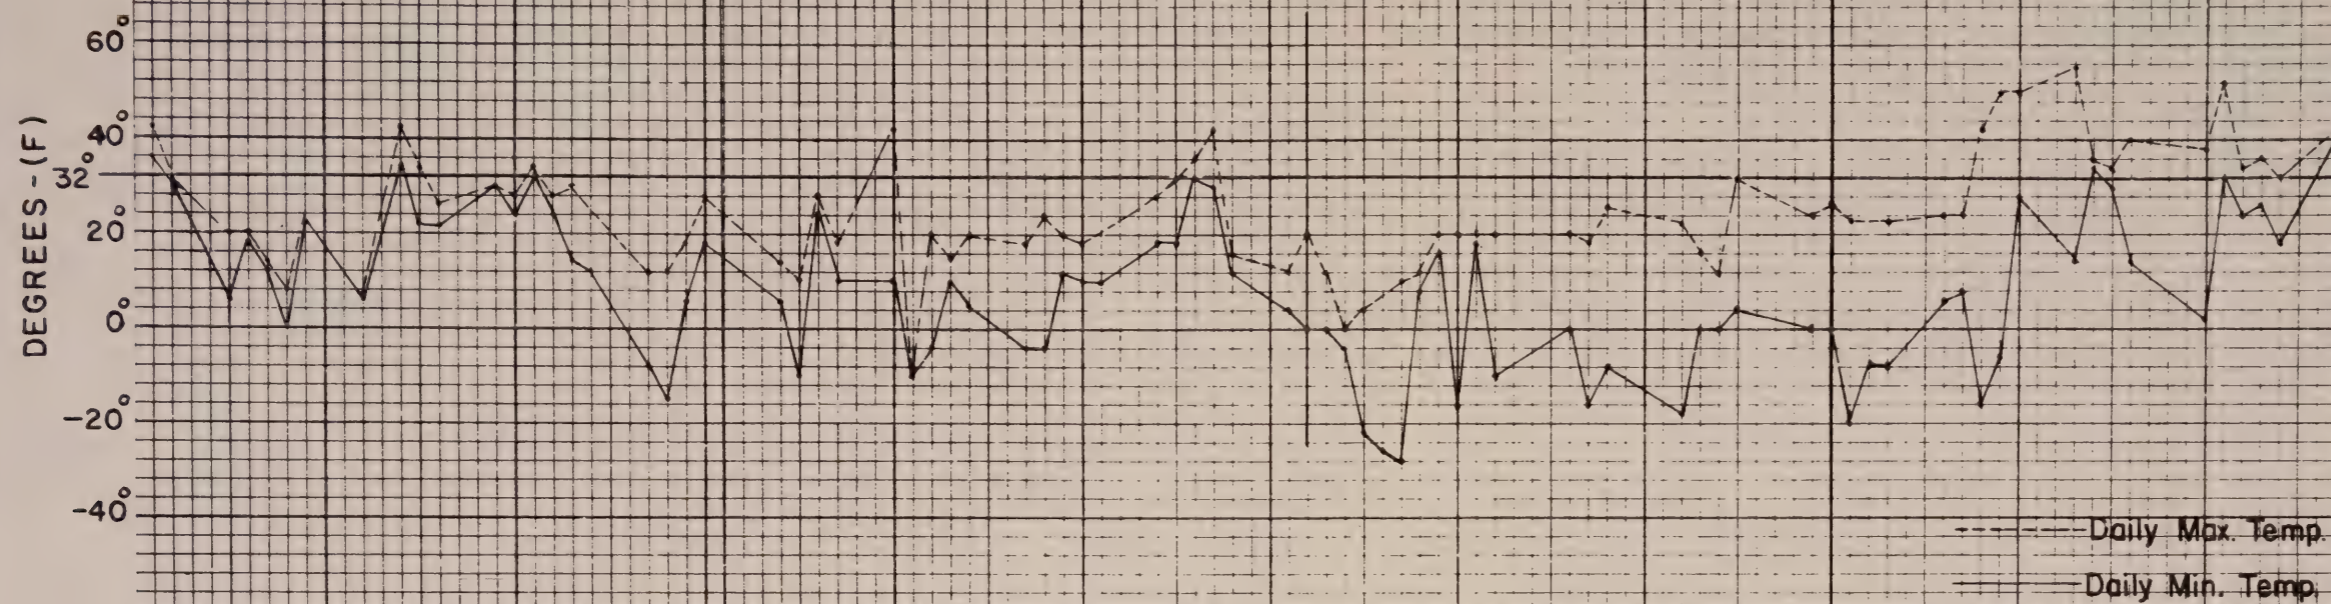
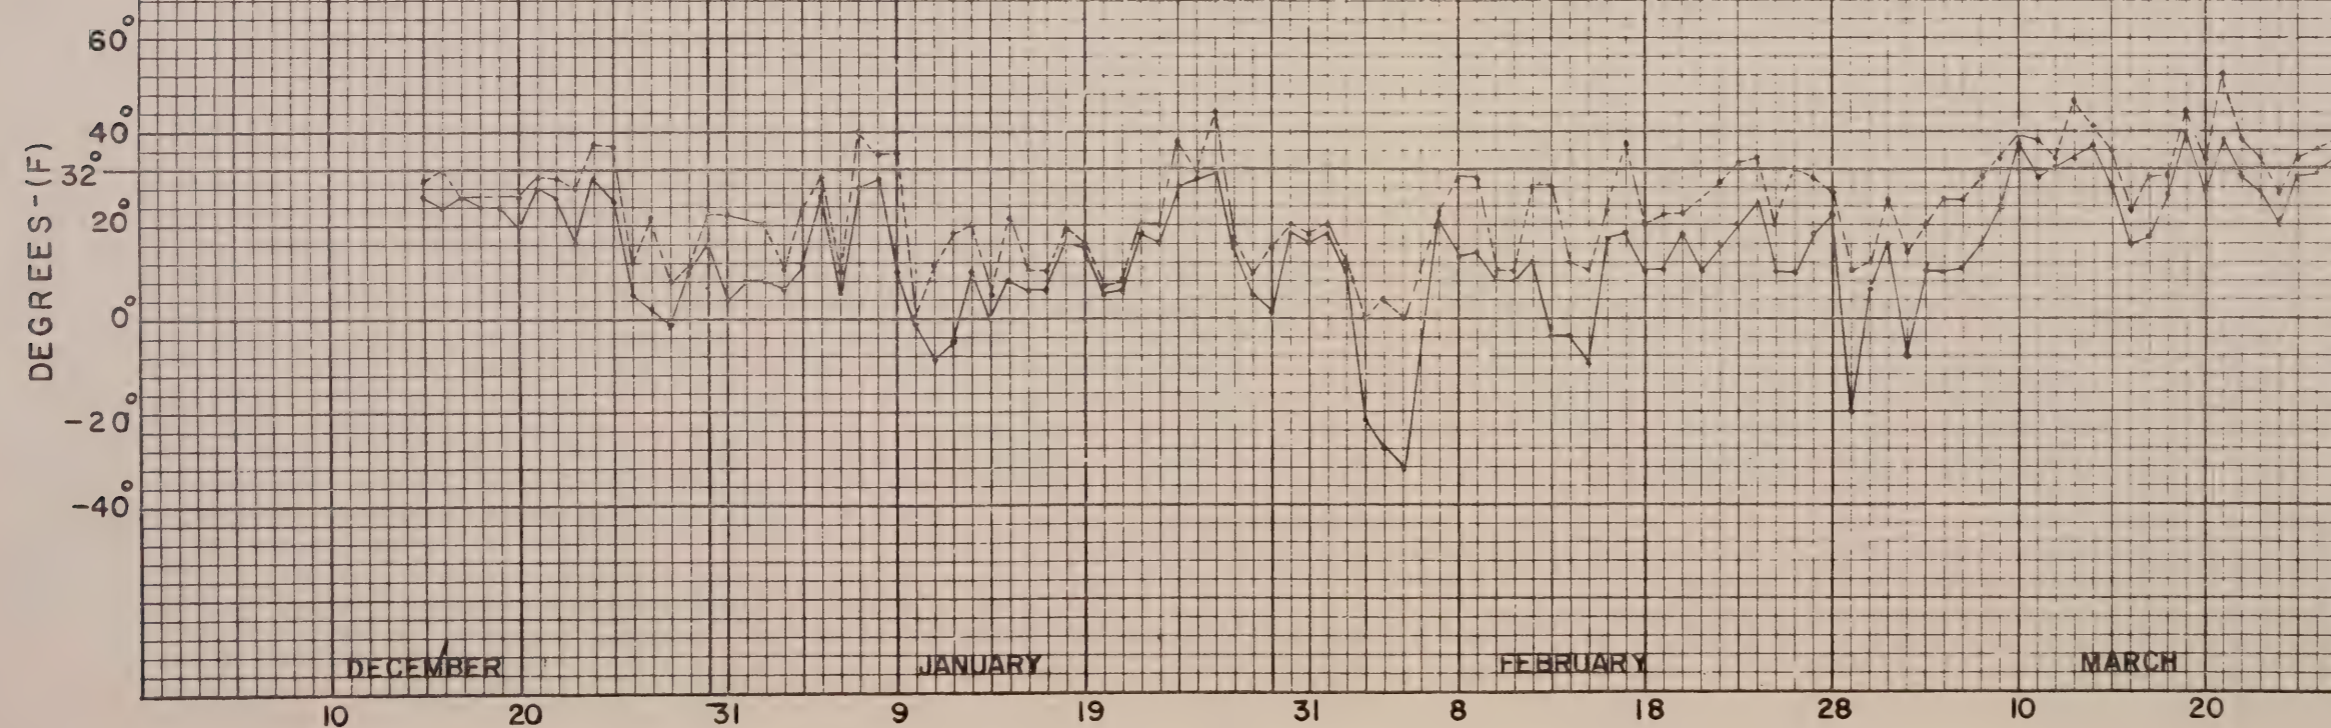
FIGURE B-2

TEMPERATURE RECORDS

North Elba Test Site

Test Site W. of Palisade Ski Area

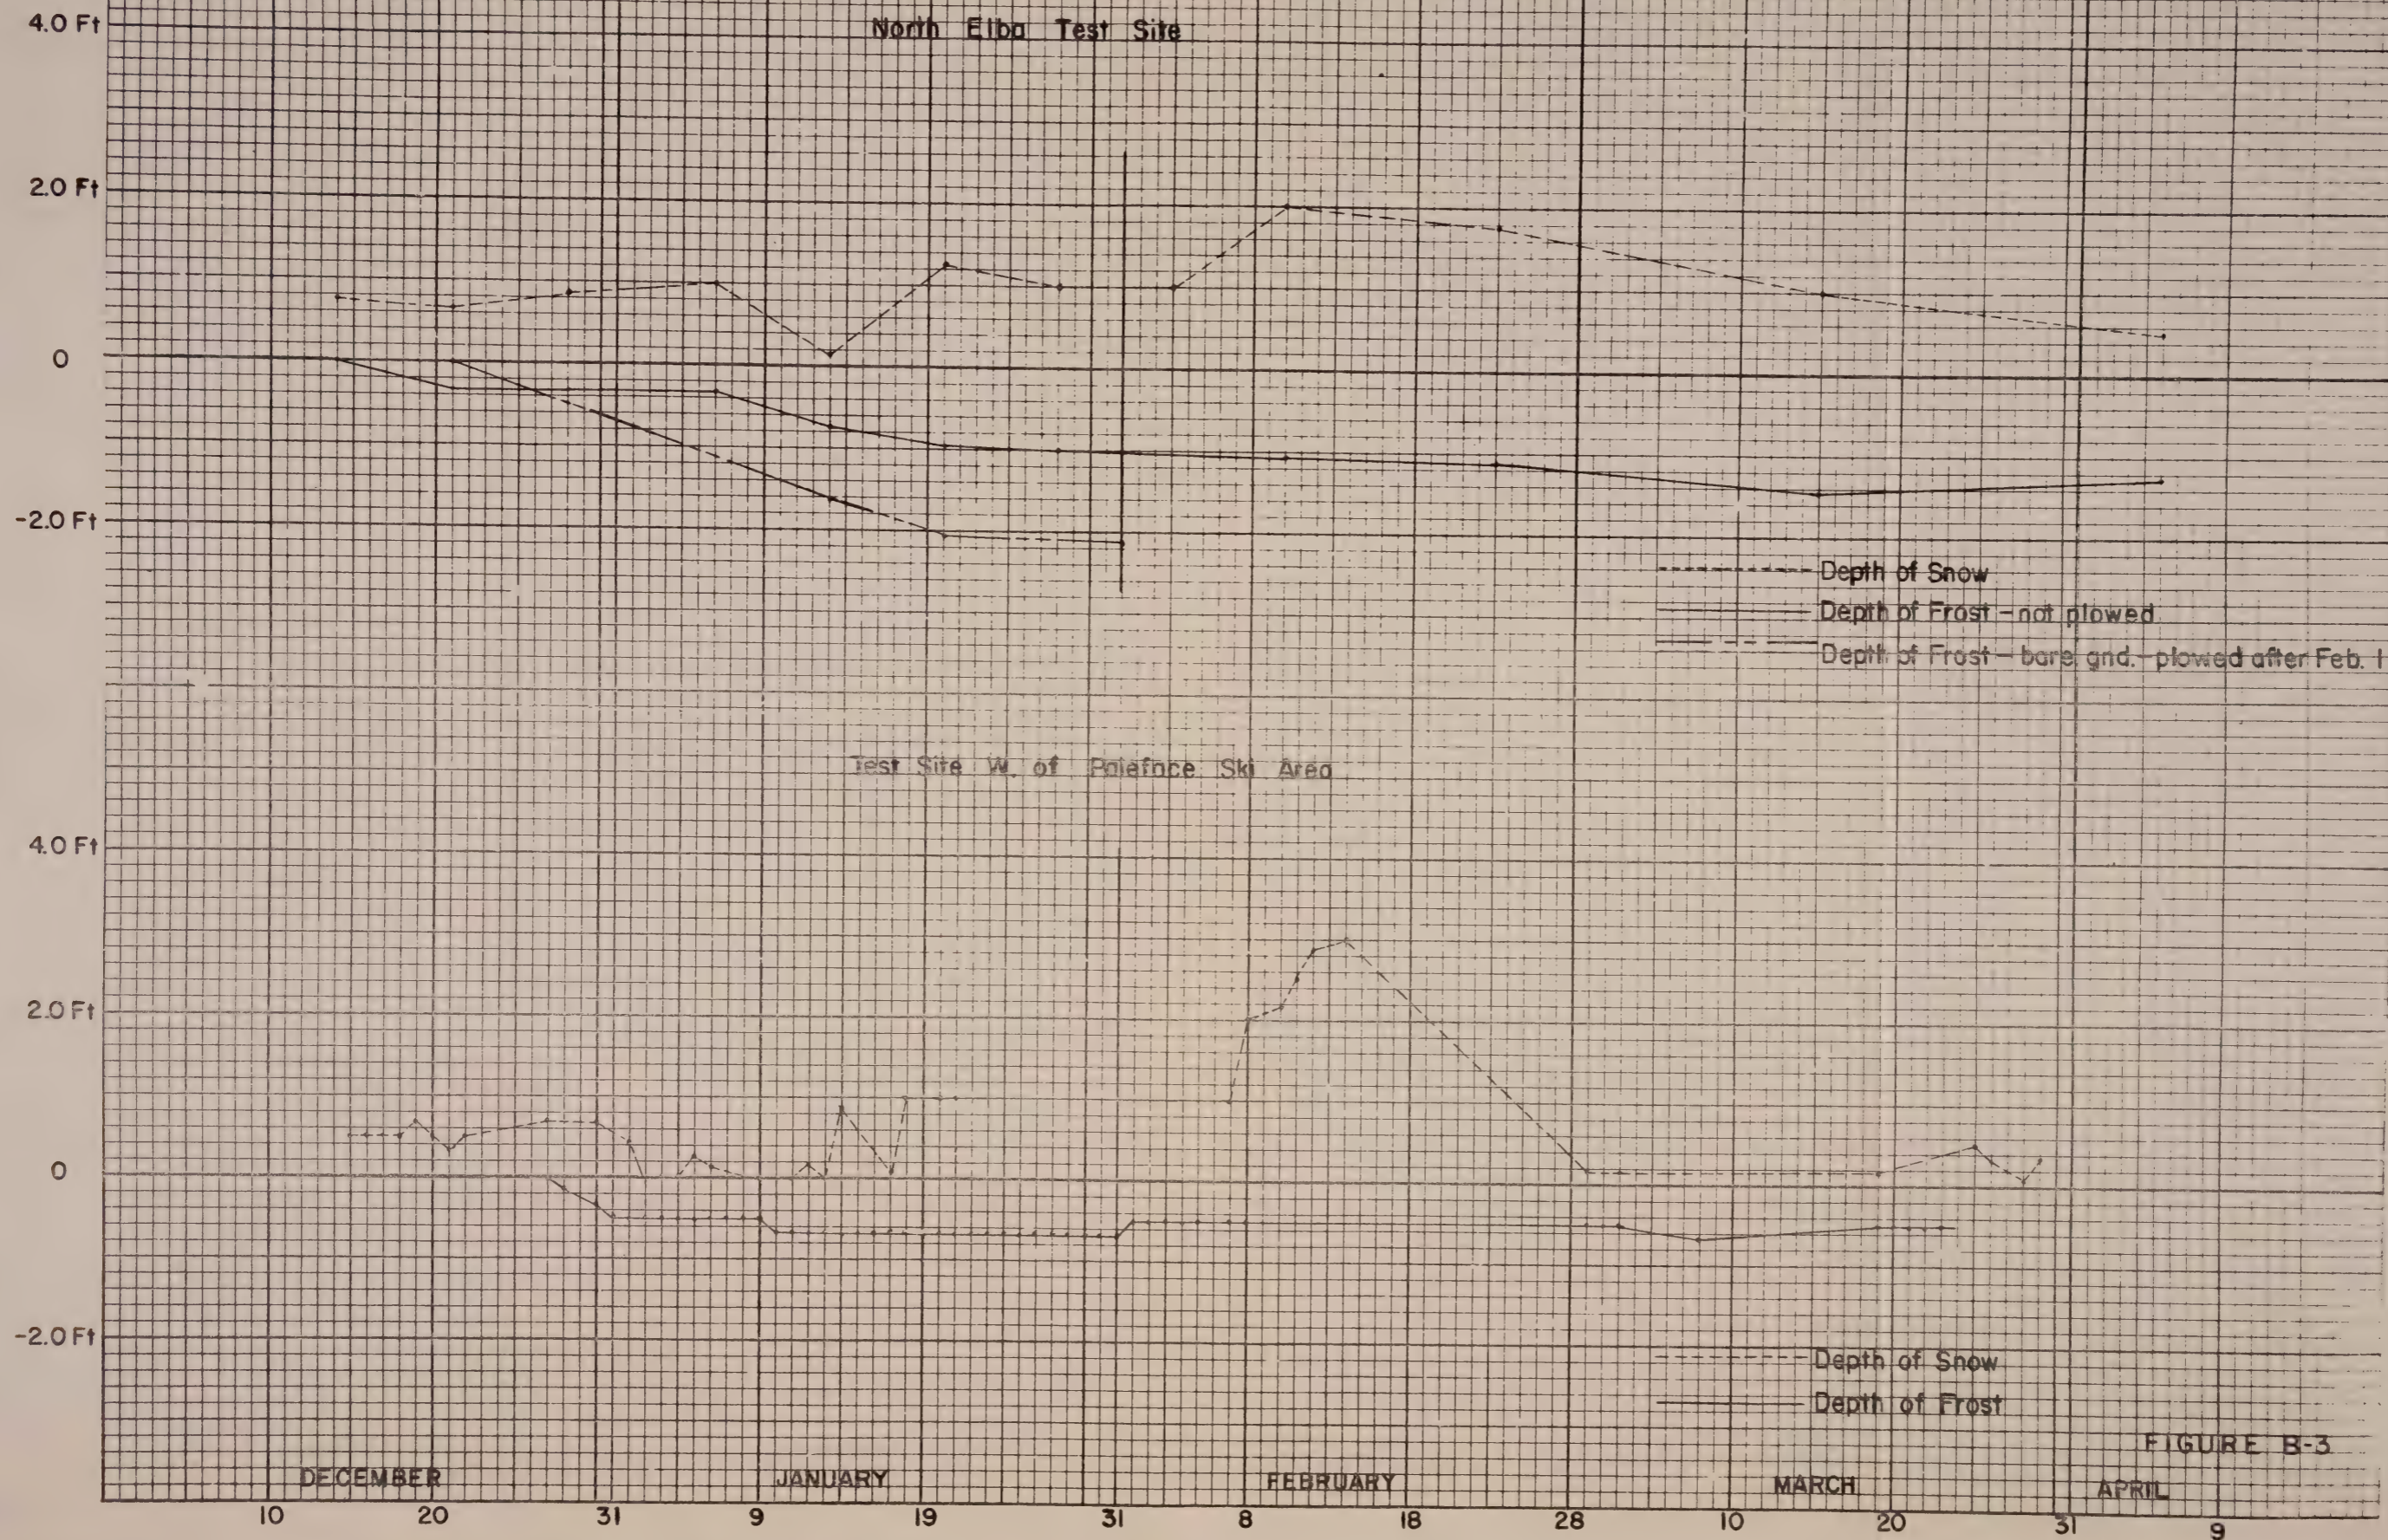
FIGURE B-3

SNOW AND FROST DEPTH RECORDS

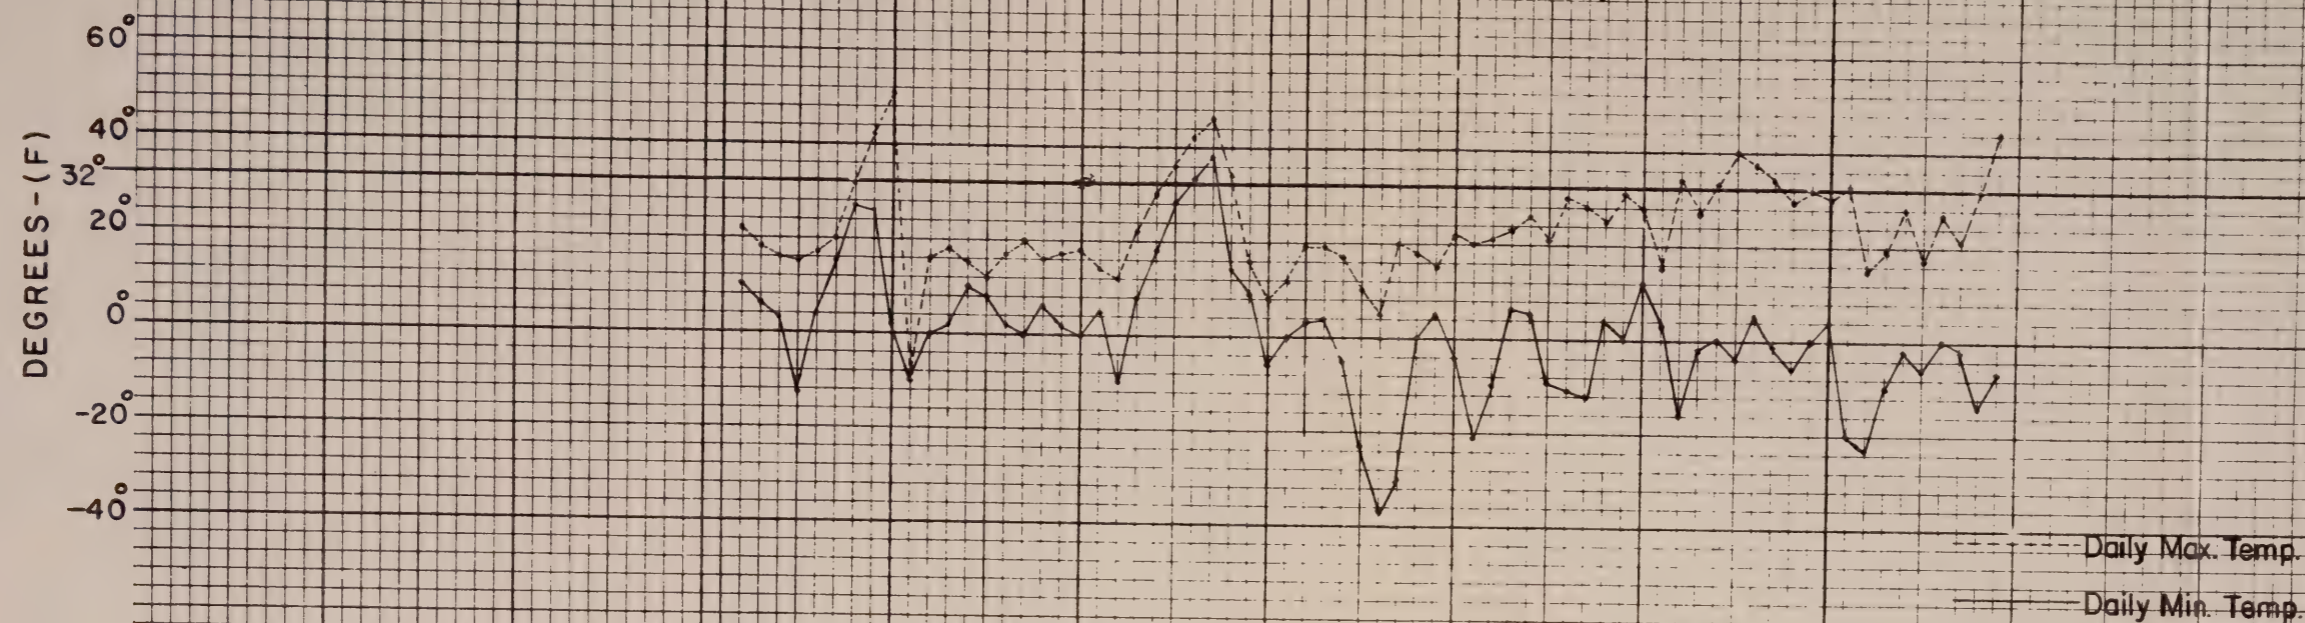
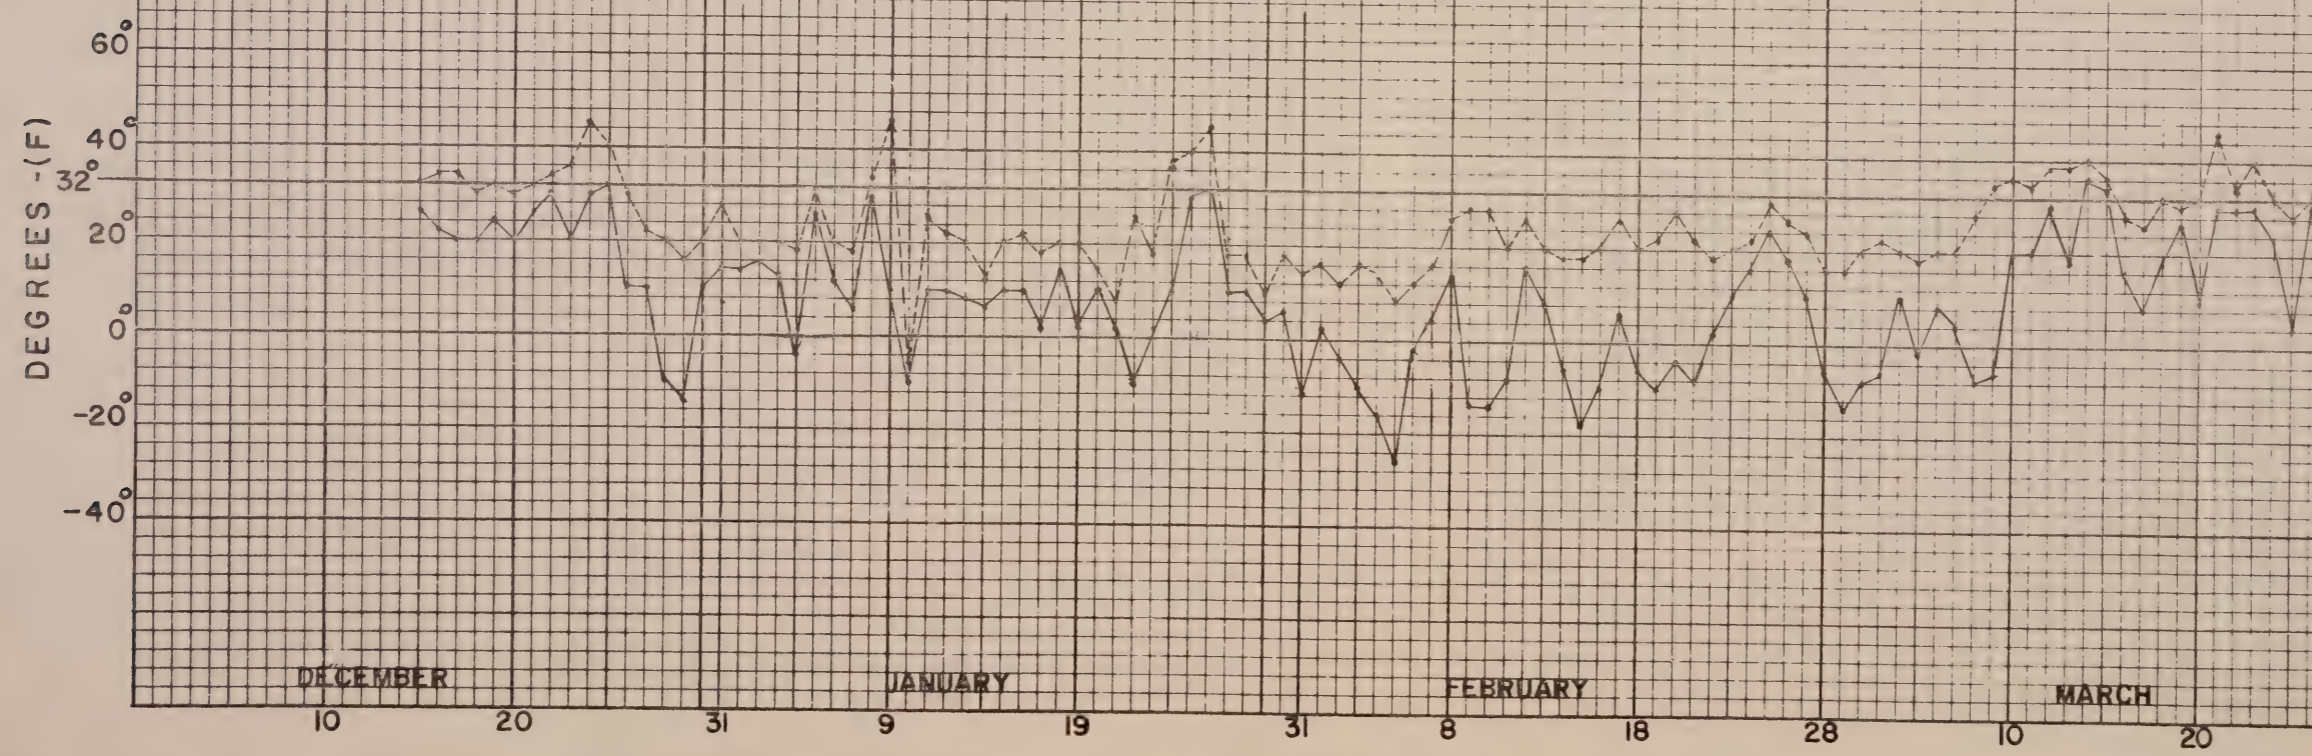
FIGURE B-4

TEMPERATURE RECORDS

Saranac Lake Landfill

Marcy Airfield Test Site
